Wakefield Run: Stream Restoration Project

Current Conditions

Plan Design

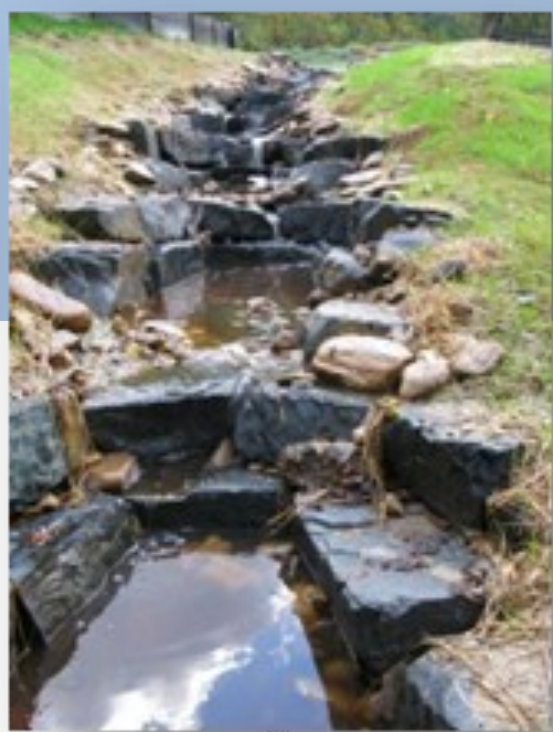
Step pools
(grade control)

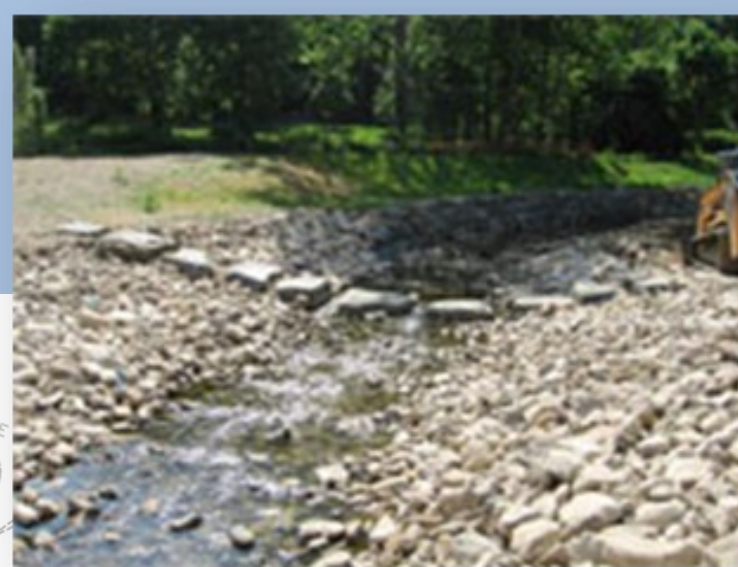
Stream crossing

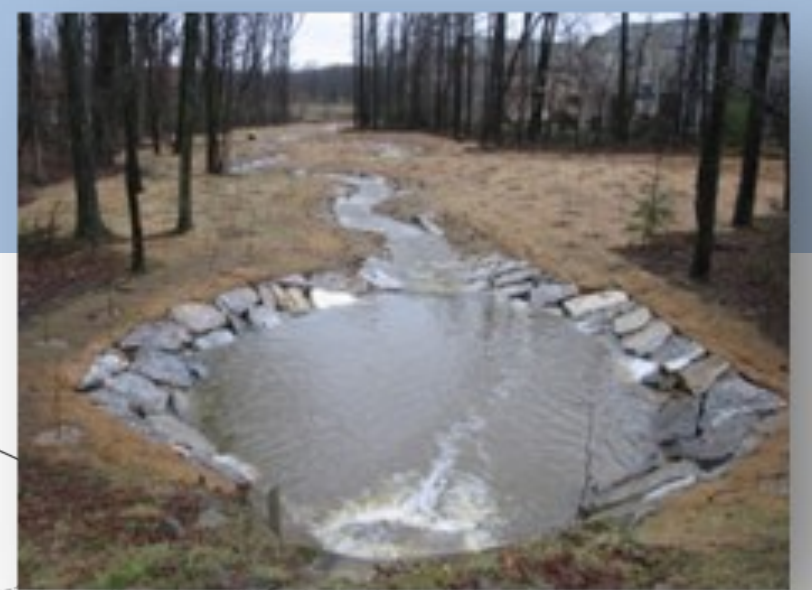
Stilling basin
(plunge pool)
